Mechanical Department Engineering Note

Number: COUPP-Doc-507

Project: COUPP-60

Title: COUPP-60 Hydraulic Hose Failure Analysis

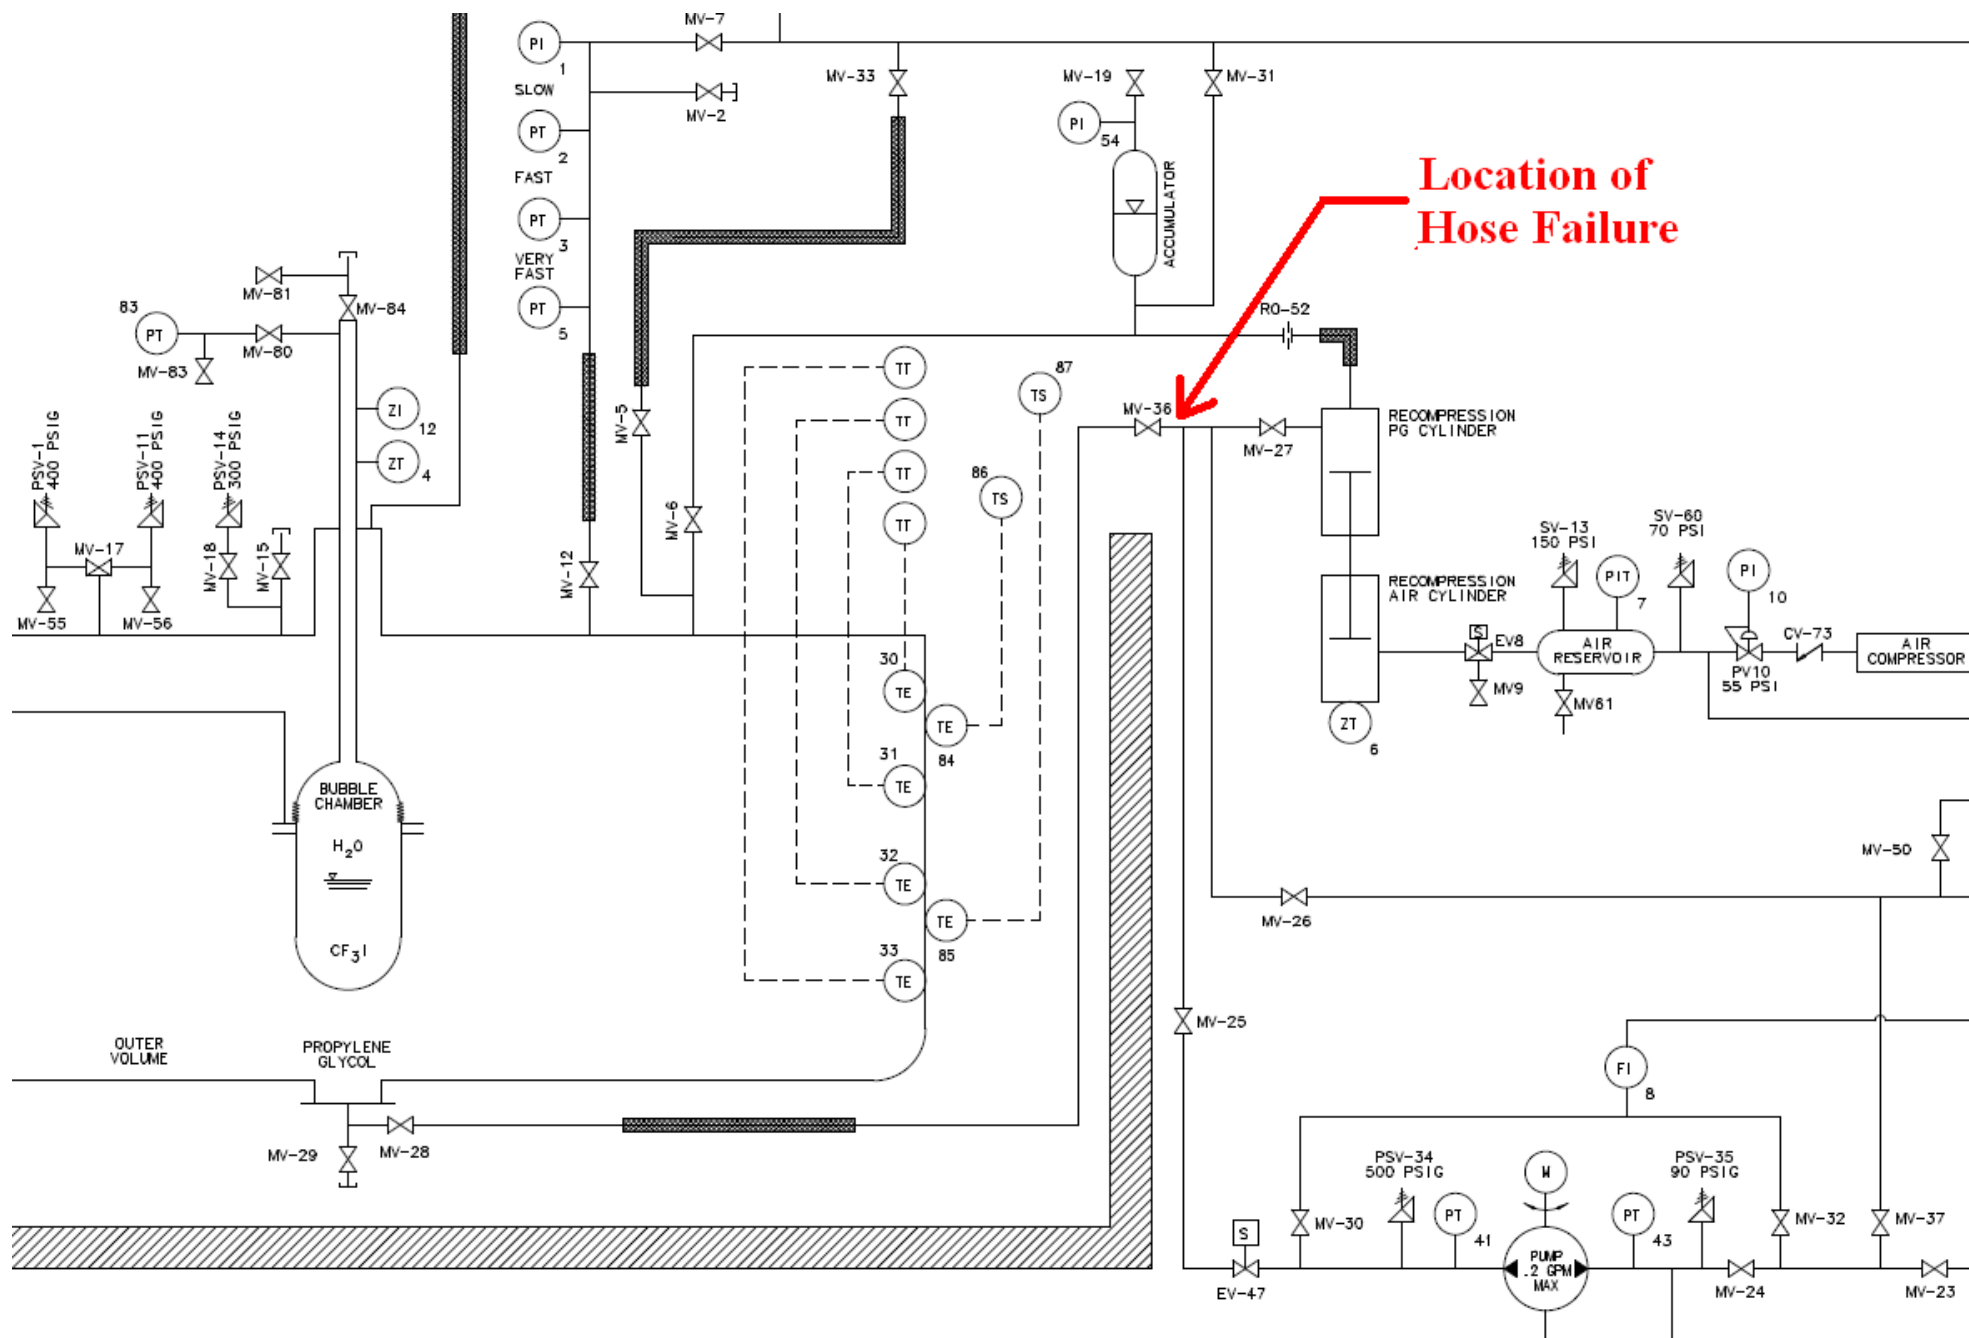
ATTACHMENT #1 lists the specific incidents preceding and after the specific hose failure. The hose, which runs between MV-27 and MV-36, see Figure 1, failed by leaking through the inner core material, through the steel braid, and into the outer jacket. Outer jackets are meant to stop abrasion of the steel braid and are therefore not designed for internal pressure. The leaking of the internal core subjected the outer jacket to internal pressure, causing it to burst, see Figure 2, and leak approximately one liter of an inhibited propylene glycol mixture, fluid specifics can be found in ATTACHMENT #4.

Figure 1: Location of hydraulic hose failure, see ATTACHMENT #2 for full P&ID.

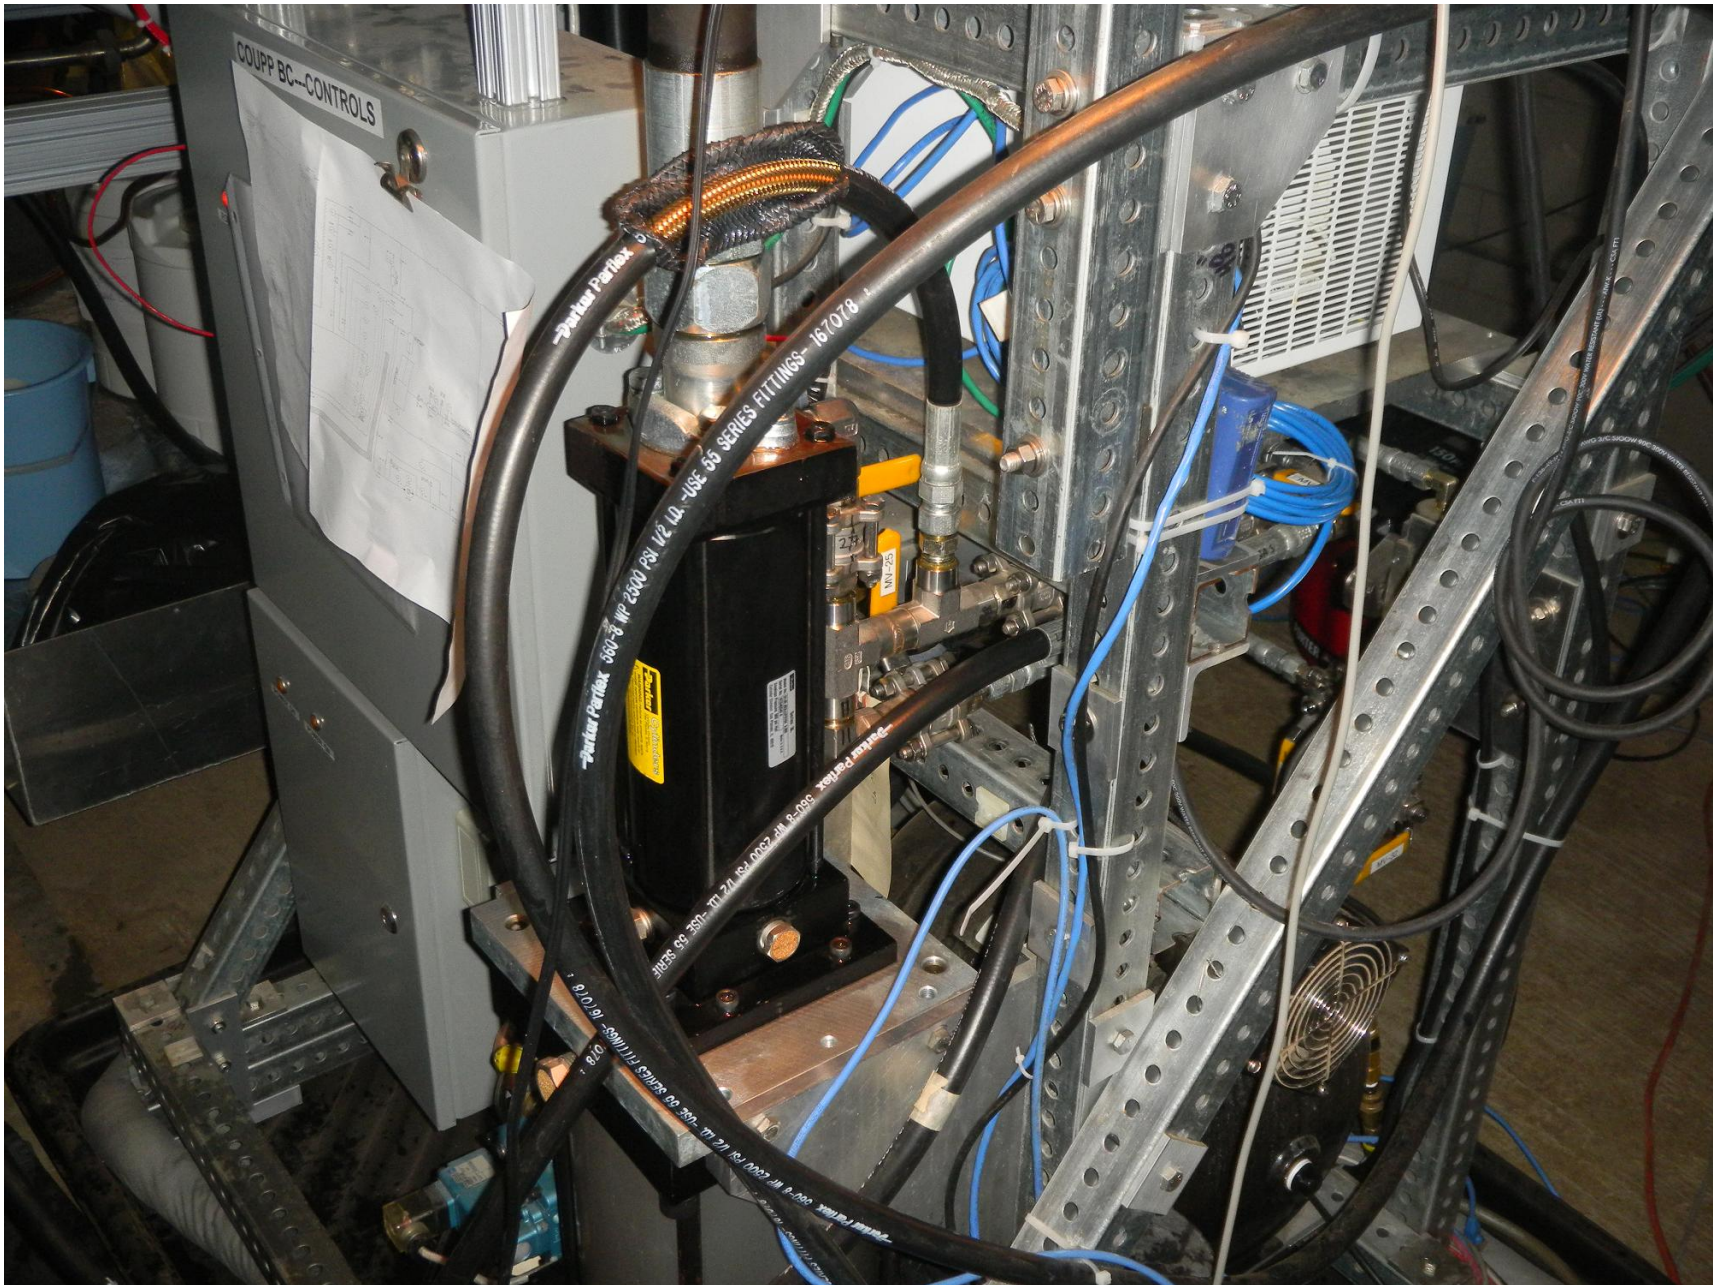
Figure 2: Image of hydraulic hose failure, note how the outer jacket burst revealing the still undamaged steel braid.

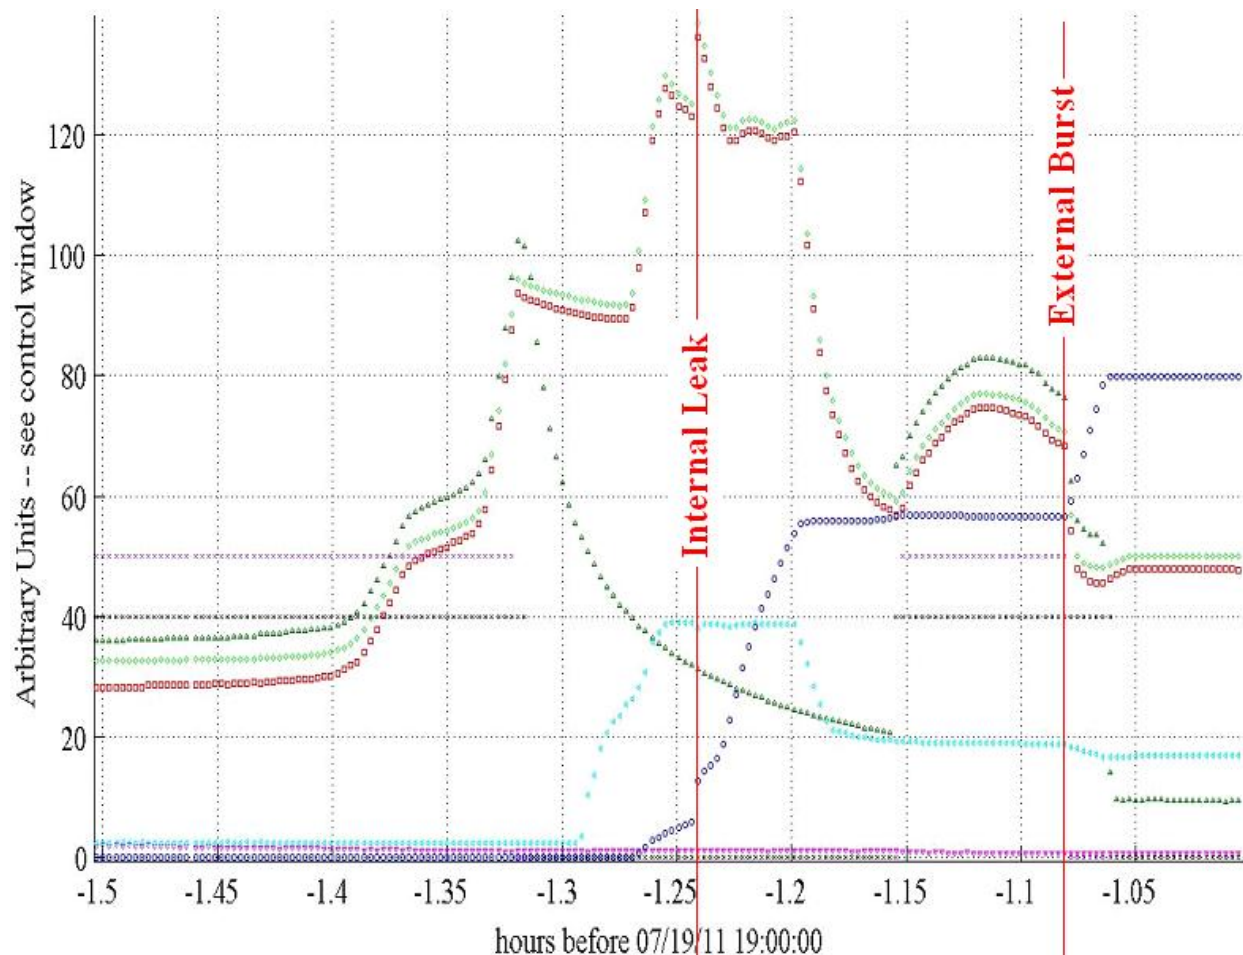
Several pressure recording devices are mounted on various parts of the experiment and all were recording during the failure. Data analysis estimates the approximate times the internal leakage and external bursting took place according to Figure 3, where we see the maximum recorded pressure was approximately 130 psi, (hose rated for 2500 psi).

Figure 3: Pressure measurements and piston position surrounding the time of failure.

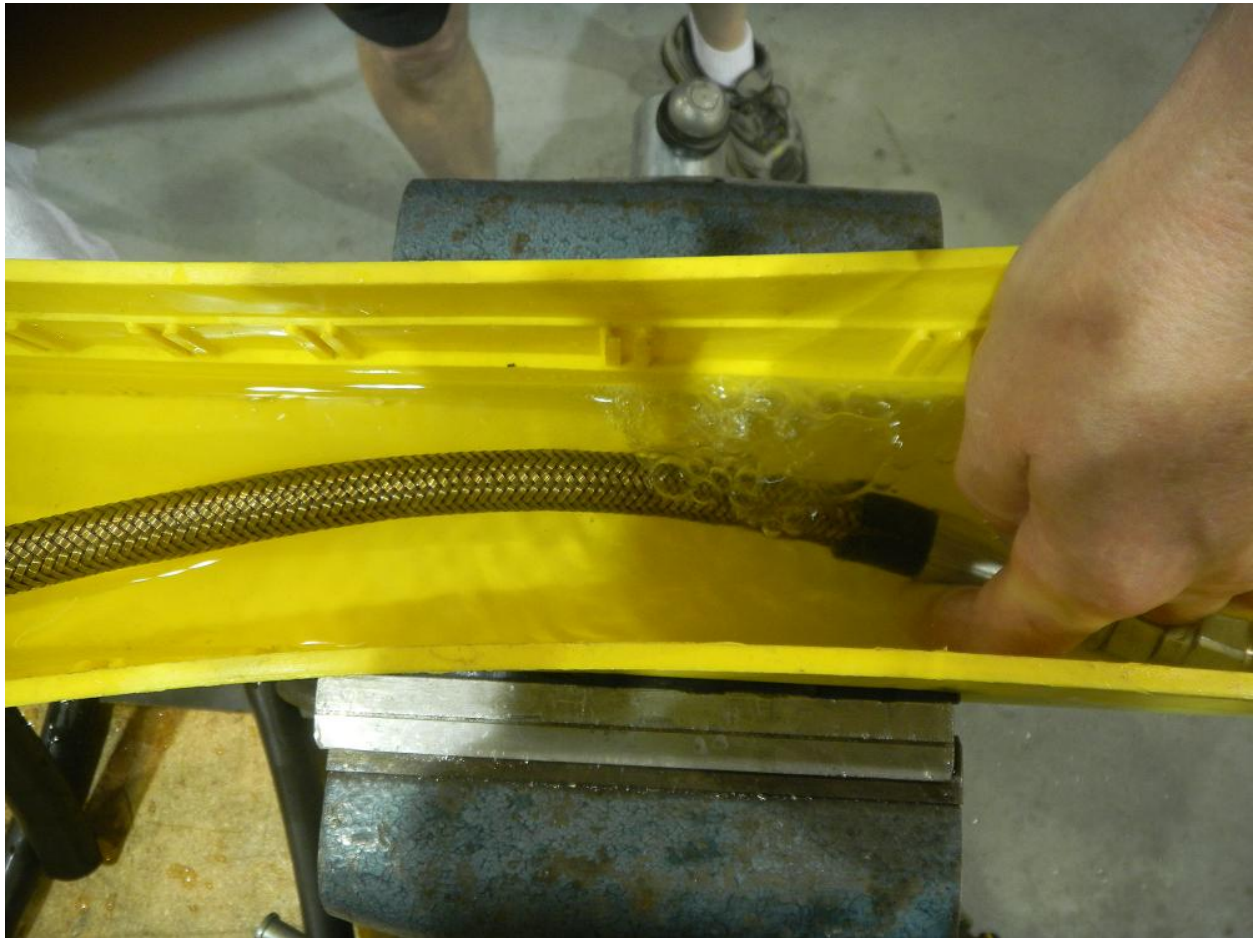
The failed hydraulic hose was removed from the experiment and examined by Mark Rushman. Once the outer jacket was removed, the hose was pressurized with air and a leak near the end coupling closest to the outer jacket rupture was found, see Figure 4. Upon removing the steel braid, two breakages in the inner hose core, near the end coupling were found, see Figures 5 and 6.

Figure 4: Leak in hose with outer jacket removed, note undamaged steel braid.

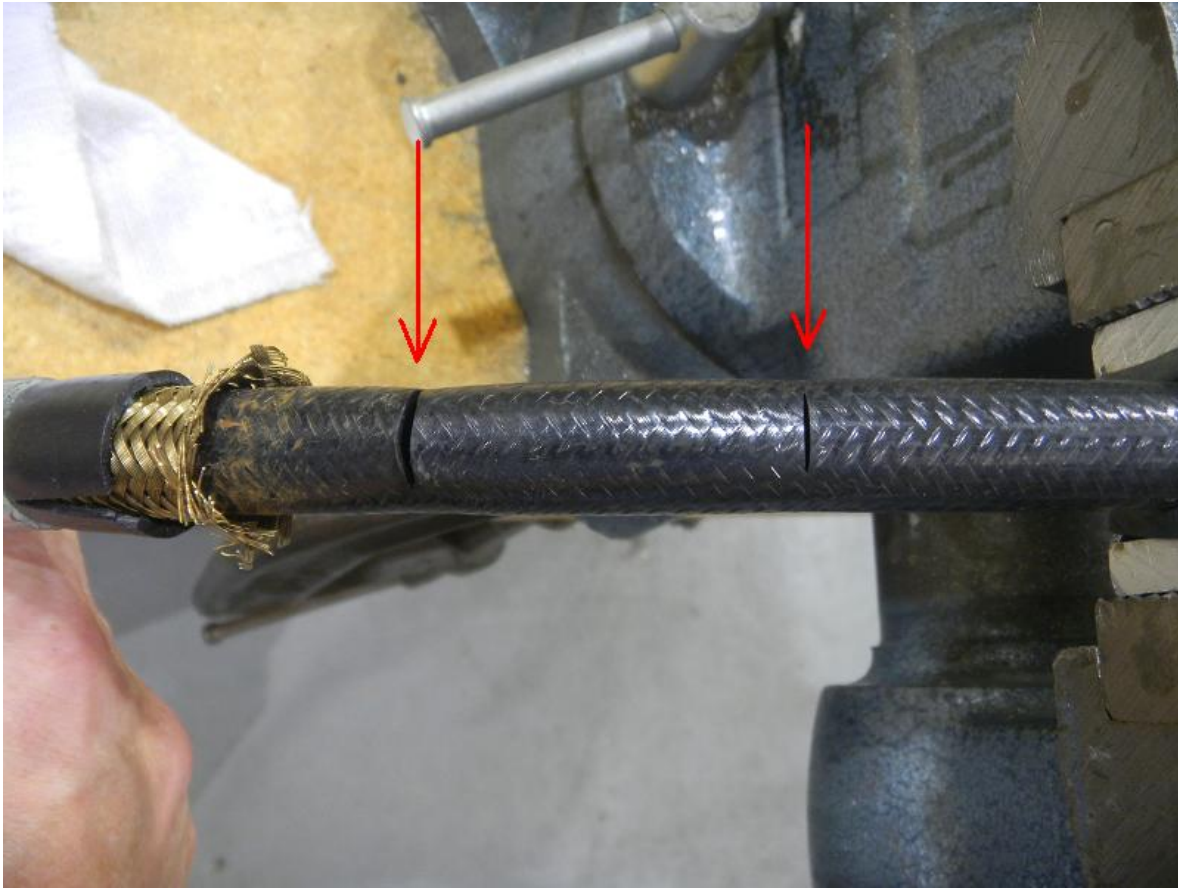
Figure 5: Two inner core breakages near end connection with removed braid.
(Note how the inner core is torn sagittally, centered about the outside of the bend)

Once even the smallest hole or split develops in this area of the outside of the bend, it becomes a stress concentration, which greatly increases the stress at each end of this split. The stress concentration results in sagittal tearing of the hose from the center of the split out across the top of the hose, see Figures 9 and 10. The end effect of this type of failure would look just like our hose failure specimen from Figures 5 and 6.

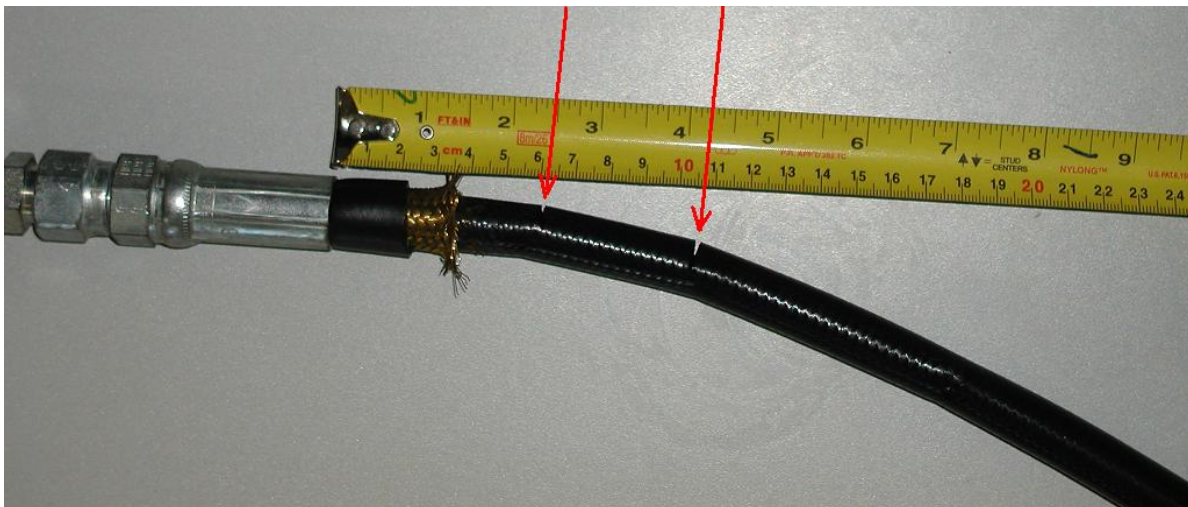
Figure 6: Ninety degree rotated view of inner core breakages, braid removed.
(Note how the inner core is torn sagittally, centered about the outside of the bend)

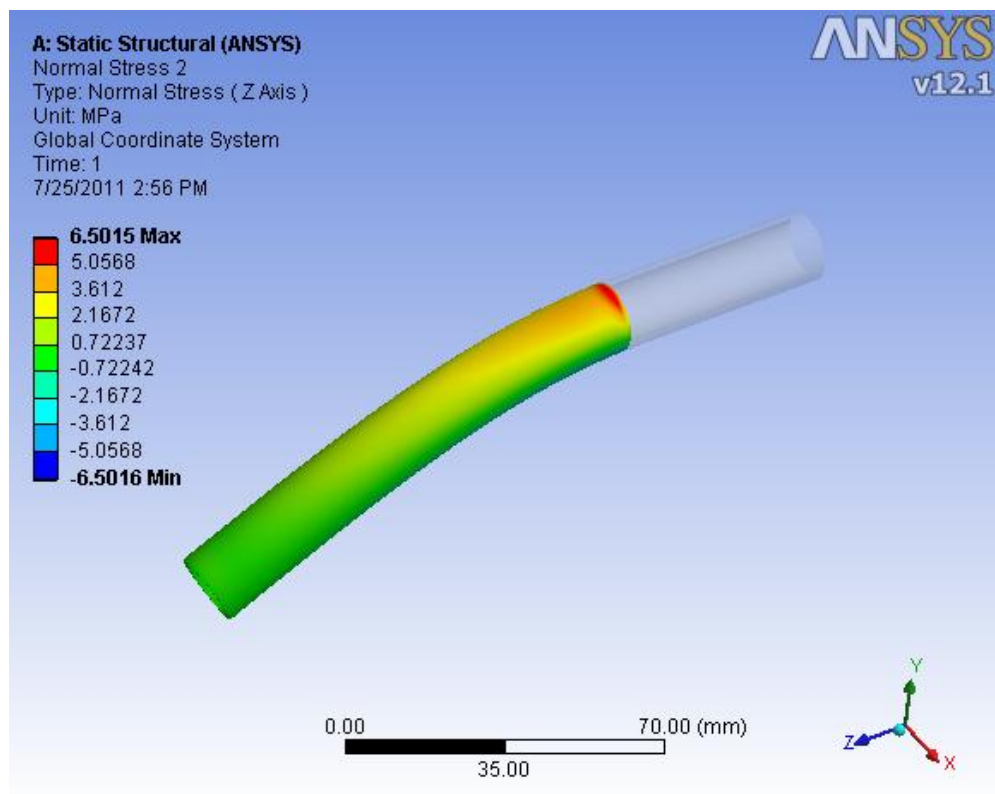
- i. Immediate examination of the type of failure indicates a bending type failure. A failure due to hose over pressure would damage the braid, and result in a longitudinal split in the inner core of the hose. The perfect example of an overpressure failure is the failure of this same hoses outer jacket, which failed due to overpressure just as described and split longitudinally. Bending of a cylindrical object, the hoses inner core, causes the stress in the object to be non-uniform, where the part of the object on the outside of the bend is in tension, and the inside of the bend is in compression. This would result in the outside of the bend being the most prone to failure as it is being pulled or torn open, since this is the area of the highest normal and shear stresses. Failure would occur starting directly on top of the outside of the bend, somewhere near the connector, see Figures 7 and 8, (the transparent area is the hose connector).

Figure 7: Maximum normal stress greatest on outside of bend near connector.

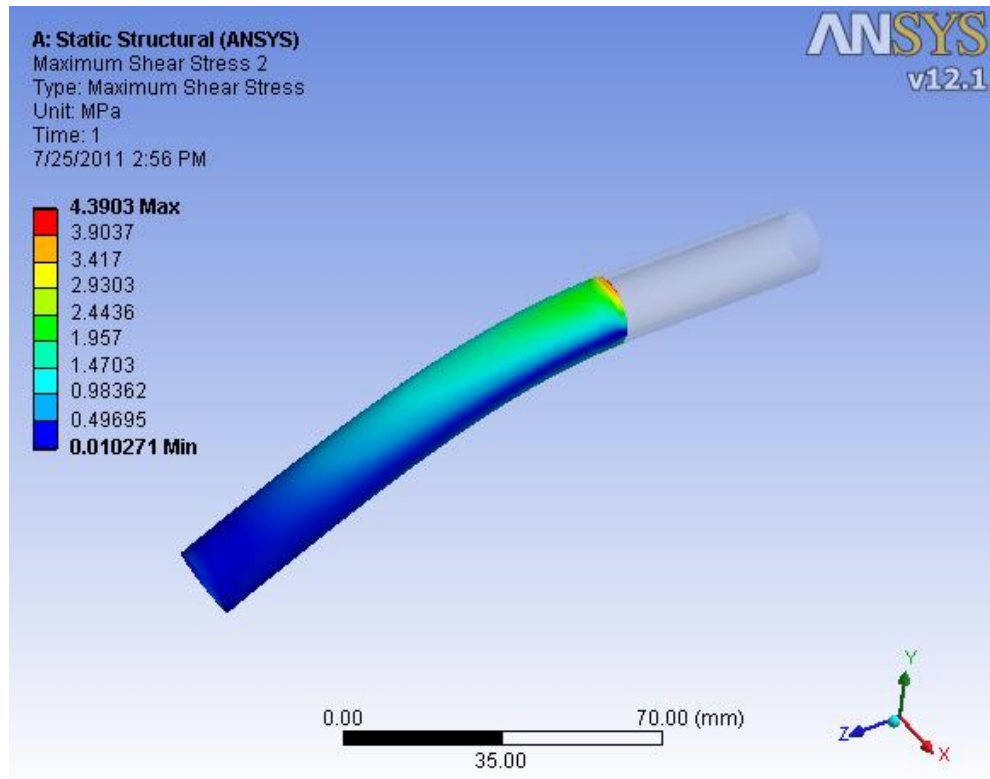
Figure 8: Maximum shear stress on outside of bend near connector.

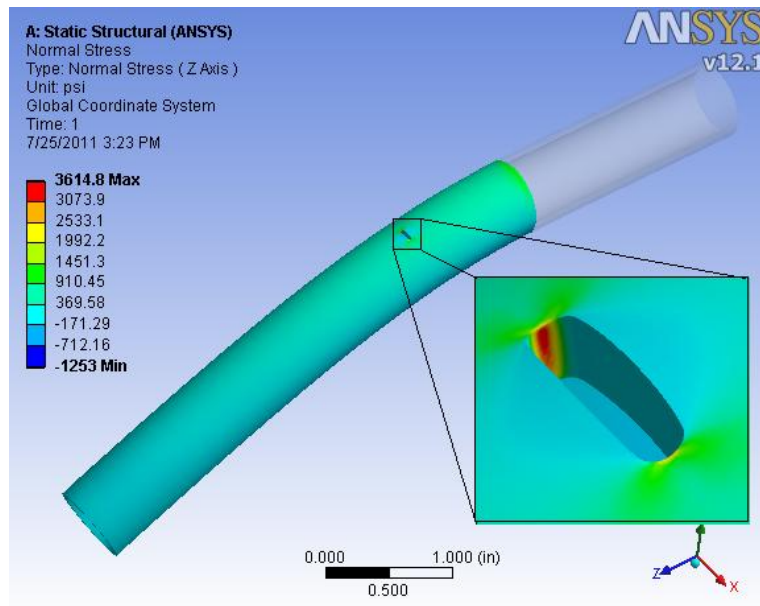
Figure 9: Stress concentration effects of small split in hose increasing normal stress.

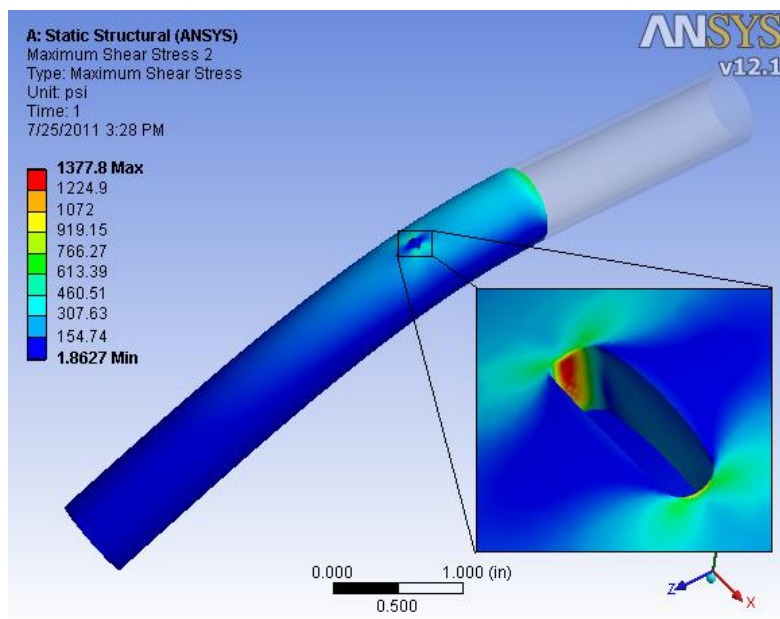
Figure 10: Stress concentration effects of small split in hose increasing shear stress.

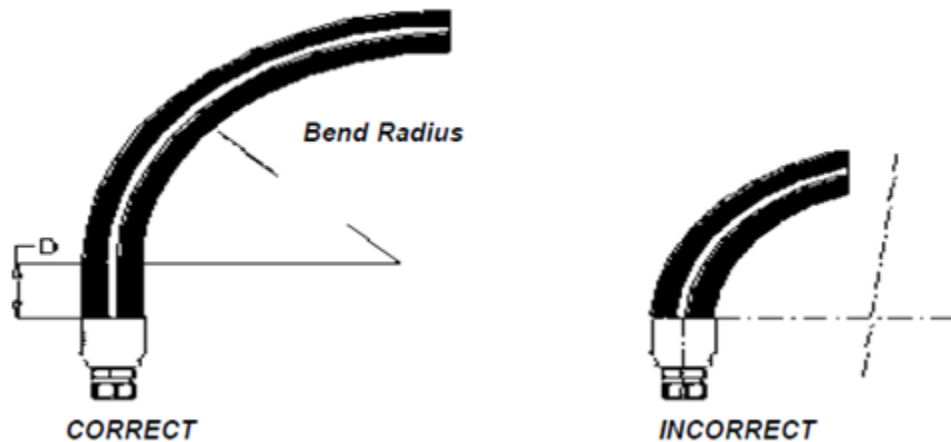
- ii. Bending a hydraulic hose in more than one plane results in twisting of its wire reinforcement. A twist of five degrees can reduce the service life of a high-pressure hydraulic hose by as much as 70% and a seven degree twist can result in a 90% reduction in service life.[1]
- iii. Inspection of the hose shows it was not bent beyond its minimum bend radius. General hydraulic hose assembly installation guidelines require different requirements for the hose area in close proximity to the connector than minimum bend radius, reasons apparent in the previous FEA analyses. Alfagomma[13] recommends a minimum straight length from the hose fittings of 6" for a hydraulic hose with an inner diameter of $\frac{1}{2}$ ". The most accentuated bends resulting from the non-compliance of this requirement may cause leaks, hose breaking or terminal loosening, see Figure 11.

Figure 11: Proper installation near hose terminals.

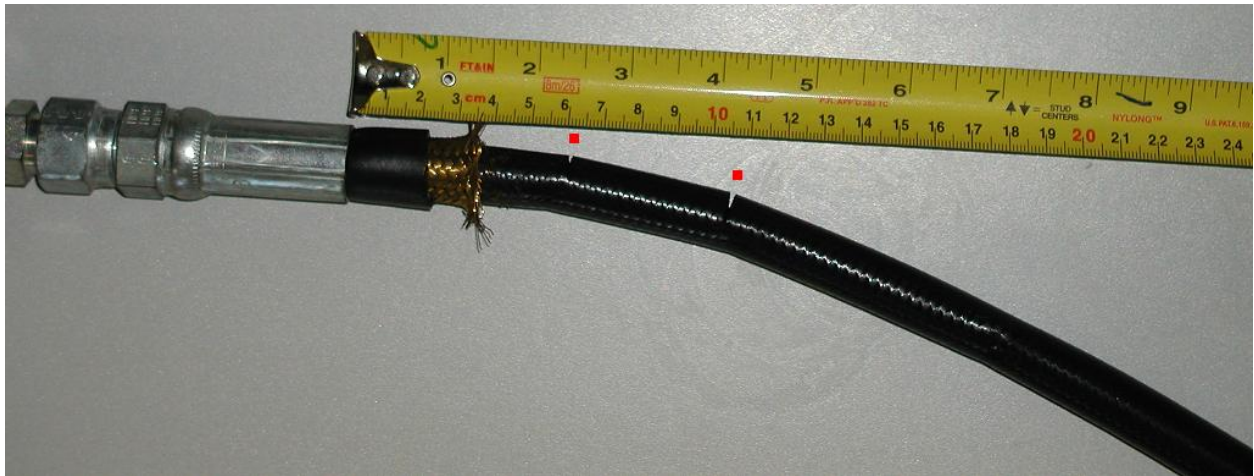
- iv. It is obvious by examining our failed hose that this installation criteria was not met. We can see in Figure 12, the plastic

deformation of the hose begins at the connector and these breakages are both inside this 6" critical area.

Figure 12: Straight length near connector not satisfied, causing breaks in critical area.

- All hoses not installed according to the recommended procedures should be replaced with nylon or EPDM core hoses. The original hoses should be discarded since their strength is already compromised due to improper installation. The new hoses shall be installed in such a way that eliminates multi-plane bending, twisting, excessive bends, and must be sized to the proper hose length.

- Hard pipe with elbows should be used wherever possible, the area of this hose failure shall be replaced by hard pipe which would result in the flexible hose having no more than two ninety degree bends, both of which must be in the same plane. The hoses must also have straight lengths near connectors which exceed the sum of the hoses minimum bend radius plus the outer diameter. Hoses must be secured with clamps to prevent any external physical abuse.

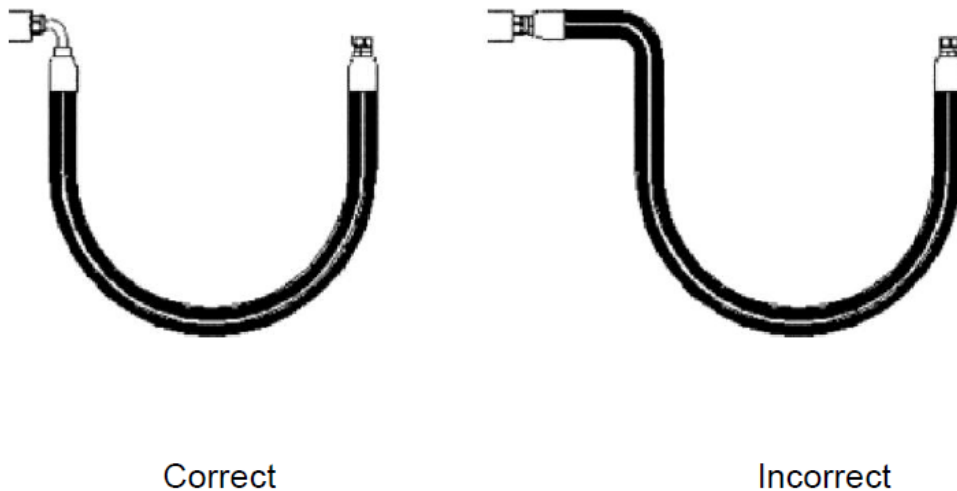
- v. Parker[5] states hoses should be installed with elbows or other adapters to ensure multi-plane bending is prevented, which includes bending in only one plane to avoid twisting, see Figure 13.

Figure 13: Use of elbows to ensure multi-plane bending or twisting is prevented.

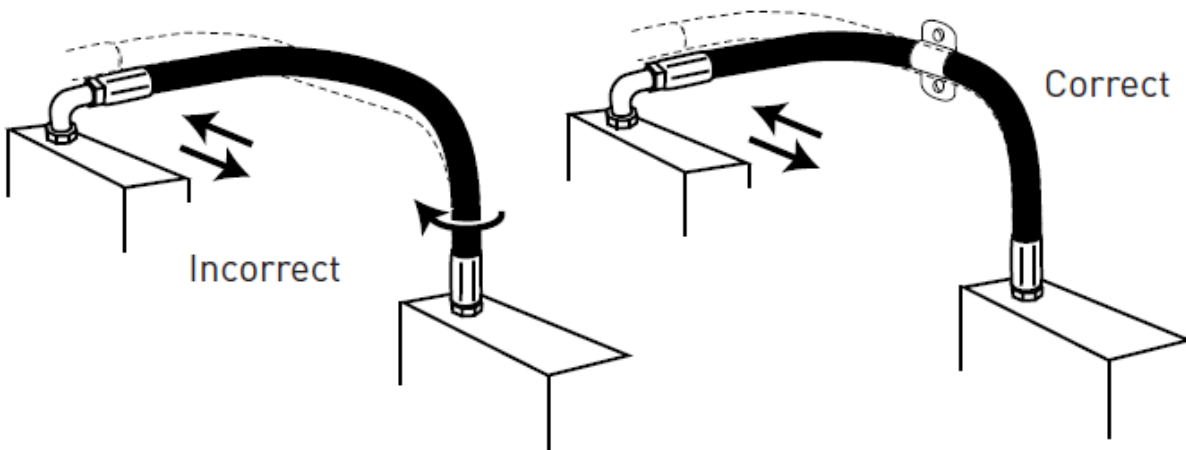
Figure 14: Segmenting hose to prevent multi-plane bending. [5]

- If absolutely necessary for a hose to follow a compound bend, it shall be secured with a clamp into two separate segments, each of which only flex in one plane, see Figure 14.
